Repair bond strengths of non-aged and aged resin nanoceramics

PURPOSE. To explore the influence of different surface conditionings on surface changes and the influence of surface treatments and aging on the bond strengths of composites to non-aged and aged resin nanoceramics.

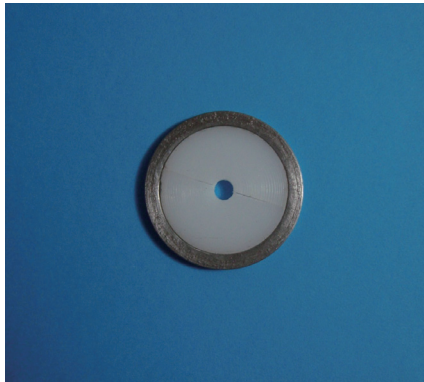
Fig. 1. The separable teflon mold used to repair the Lava Ultimate (LU) specimens.

After the roughness measurement, a repair procedure was performed. For the repair of LU material, an adhesive (Single Bond Universal Adhesive, 3M ESPE, Neuss, Germany) and nanohybrid universal composite (Filtek Z550, 3M ESPE, St. Paul, MN, USA) were used (Table 1). To limit the bonding area, an adhesive tape with a diameter of 5 mm was placed at the center of each specimen. The material's surface was brushed with adhesive, gently air dried for 5 seconds, and light polymerized for 10 seconds. Next, a separable special teflon mold (radius: 5 mm, height: 2 mm) (Fig. 1) was placed on the bonding area. Composite material was packed into the mold and polymerized for 40 seconds using a light curing unit (Elipar S10, 3M ESPE, St. Paul, MN, USA).

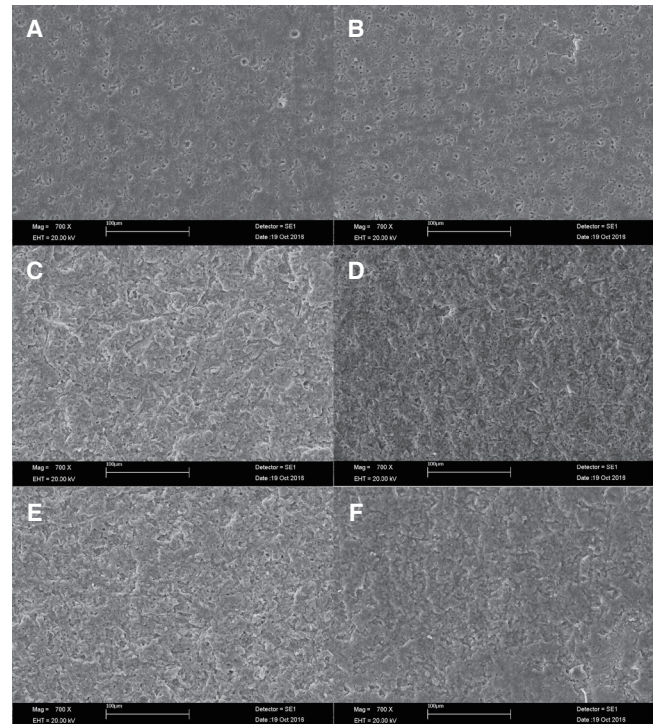
Fig. 2. Representative images from scanning electron microscopy of surface-treated non-aged and aged LU. (A) Non-aged untreated LU. (B) Aged untreated LU. (C) Non-aged air-abraded LU. (D) Aged air-abraded LU. (E) Non-aged silica-treated LU. (F) Aged silica-treated LU (magnification, ×700).

SEM images of the surface-treated LU specimens are given in Figure 2. The effect of surface treatment on non-aged LU was more prominent than that on aged LU. Unlike the untreated specimens (Fig. 2A, Fig. 2B), microretentive surface topography could be seen in the air-abraded and silica-treated specimens (Fig. 2C - 2F). In addition, there were more small holes on the surface of the untreated aged LU (Fig. 2B) than on the untreated non-aged LU (Fig. 2A).

The roughness analysis revealed that air abrasion and silica treatments resulted in higher roughness, compared to the untreated group ($P = .000$). The SEM images (Fig. 2) verified these findings. In the SEM images, the effect of surface treatment in the non-aged LU specimens (Fig. 2A, Fig. 2C, Fig. 2E) was more prominent than in the aged LU specimens (Fig. 2B, Fig. 2D, Fig. 2F). In the untreated group of aged LU material (Fig. 2B), the number of holes on the material surface was greater than that in the untreated group of non-aged LU material (Fig. 2A). This could be due to hydrolytic degradation of the LU material that occurred owing to aging before the repair procedure. Based on the roughness and SEM results, either surface treatment (air abrasion or silica) can be used for roughening non-aged and aged LU material. Therefore, the first hypothesis was accepted.
