CONDITION SURVEY OF HISTORIC BUILDINGS BY VISUAL INSPECTION - CASE STUDY: MURAT PASHA MOSQUE

Meltem VATAN

3. CONDITION SURVEY OF MURAT PASHA MOSQUE

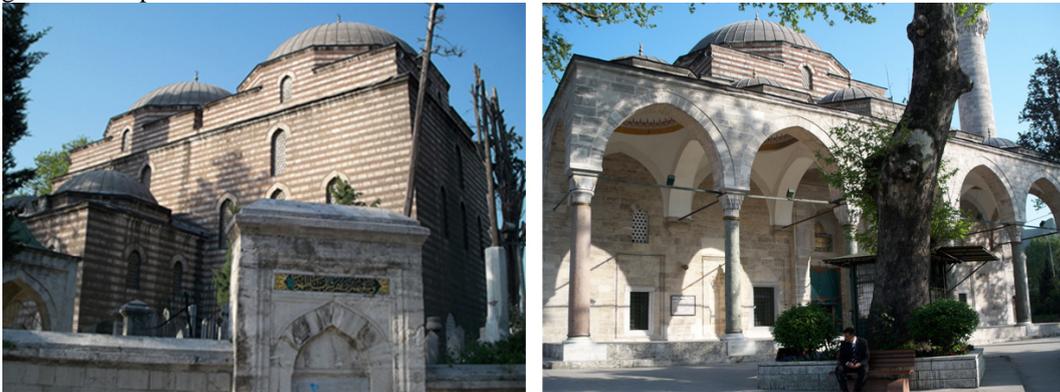
Fig. 2 Photos of Murat Pasha Mosque

Main part of the building is distinctively higher than adjacent parts. Construction type is masonry and used material is brick and stone masonry with mortar. Figure 2 shows photos of the mosque.

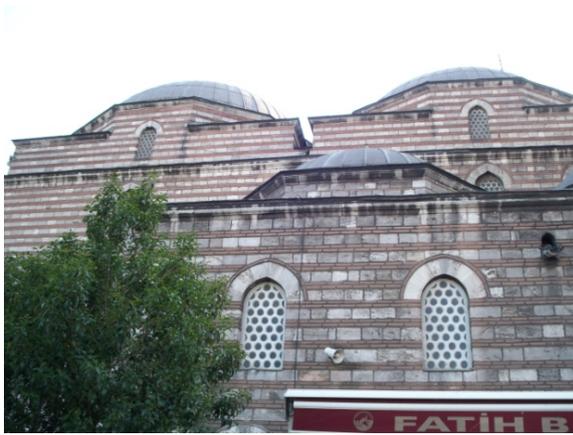
Darkness of the surface mainly due to CO_2 , uprasing of the surface of the walls, wetness, erosion, moss, cracks due to freeze-thaw actions (Fig. 6). All observed decays and damages are superficial and there is no serious damage on the facades' walls.

Fig. 6 Exterior walls

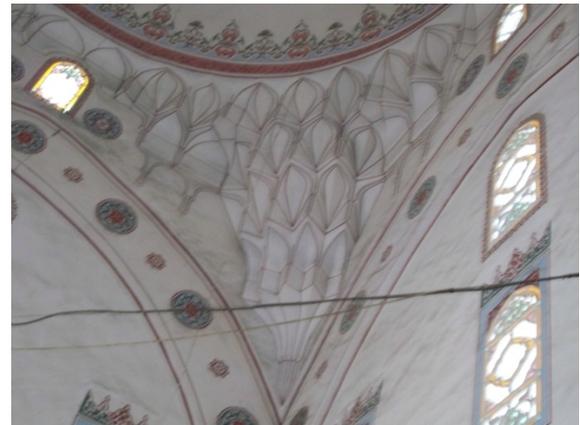
There are not significant decay and damages on the arches, transition elements and domes. Similarly the roof structure is in good condition (Fig. 8).

Fig. 8 Transition element, pendentive, of the main dome

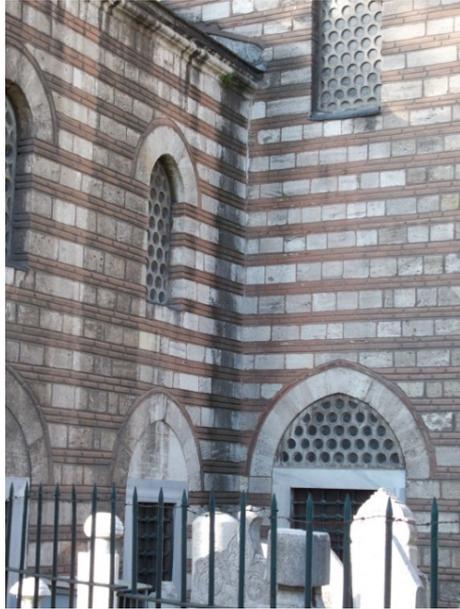
T shape building geometry itself is dangerous against earthquake loads. Due to this fact during surveying of the building it is given special attention to find out if main part and adjacent parts of the mosque are constructed separately with joint gaps. If it is, in this case the building will behave as three different buildings during an earthquake and the safety wouldn't be in danger due to the geometric shape of the building. Construction of the walls of adjacent parts is particularly investigated and it is decided that highly possibly there are joint gaps between main part of the building and its adjacent parts (Fig. 9). The construction of the wall and order of stones and bricks seems that there are two different structural walls without connection.

Fig. 9 The corner joint of the walls of adjacent part and main part of the building

This result shows that in case of repair, restoration or any intervention it is very important paying attention to the attached walls with different heights and wouldn't tend to connect those walls structurally. Detailed investigation of the walls'

construction is required before any intervention decision.

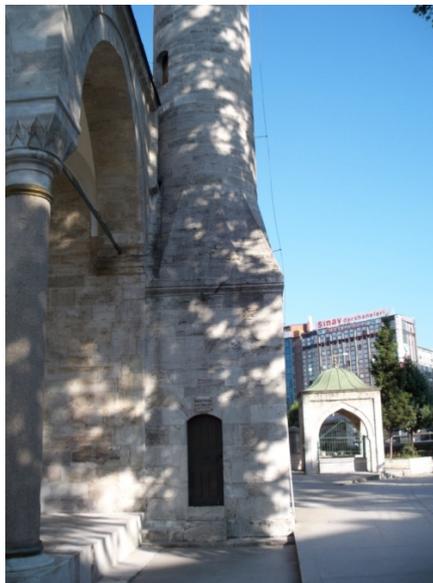
Due to the fact that minarets are slender elements obviously the weakest part of the building is minaret that could be collapse from the level of adjacent wall (Fig. 10).

Fig. 10 The minaret of Murat Pasha mosque
