# ***Minimally Invasive Restoration of Erosive Lesions With Direct Composite Laminate Veneers: A Case Report***

**Objective:** The purpose of this case report was to restore erosive lesions on maxillary central teeth with direct composite laminate veneers.

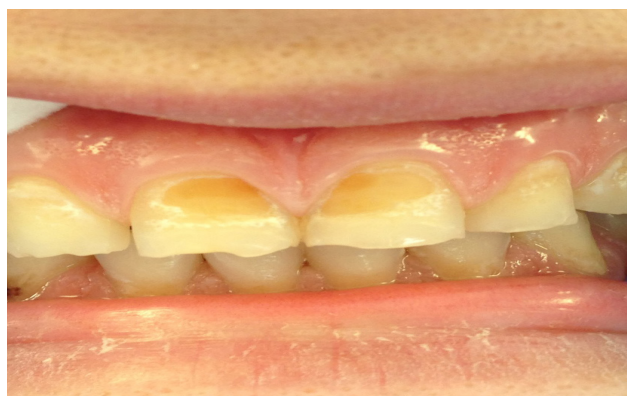
34 years old female patient referred to Istanbul Aydın University Faculty of Dentistry Restorative Dentistry Department because of aesthetic complaints. Patients' main problem was the erosive lesions especially on the maxillary central teeth (Figure 1). A detailed history was taken to determine the reasons of erosion lesions. On questioning about her eating habits related to tooth erosion, the patient declared that she had been consuming lemon regularly every week and during her pregnancy she had eaten at least one kilo of orange every day. She also stated that she was brushing very hard and clenching her teeth. On clinical examination, erosive defects mainly at the maxillary central teeth and worn incisal edges were observed. There were also NCCLs on #32,33,34,35 and #42,43,44,45 due to traumatic tooth brushing. The patient did not complain about dentin hypersensitivity. Periodontal examination revealed no signs of periodontal disease. Medical anamnesis showed of no evidence of systemic disorders.

*Figure 1. Initial appearance of the maxillary central teeth with erosive lesions and worn incisal edges*

A treatment plan was made and presented to the patient. In the plan, direct composite laminate veneer restorations for #11, 12, 13 and #21, 22, 23 were recommended. After restorations, occlusal splint was also proposed due to the teeth clenching. The patient consented the treatment procedure for only the restorations of the maxillary central teeth.

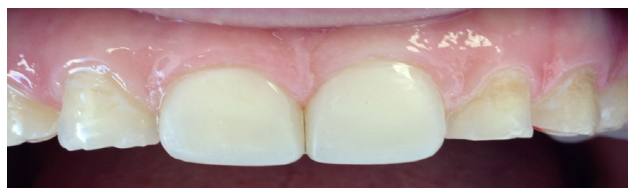
*Figure 2. The final view of the maxillary central teeth restored with direct composite laminate veneers*

For the finishing and polishing procedures, first a green-banded then a yellow-banded needle bur was used under water-cooling. Early contacts were controlled with the articulation paper. For the advanced polishing, discs (Sof-Lex XT Discs, 3M ESPE, Dental Products, USA) were applied from coarse to fine grits. At the end, a white polishing rubber was used for the final view (Figure 2).
