The Closure Screw Loosening Complication of Single-Molar Implant Mimicking Peri-Implant Mucositis: A Case Report

Sibel DİKİCİER¹, Emre DİKİCİER², Jülide ÖZEN³

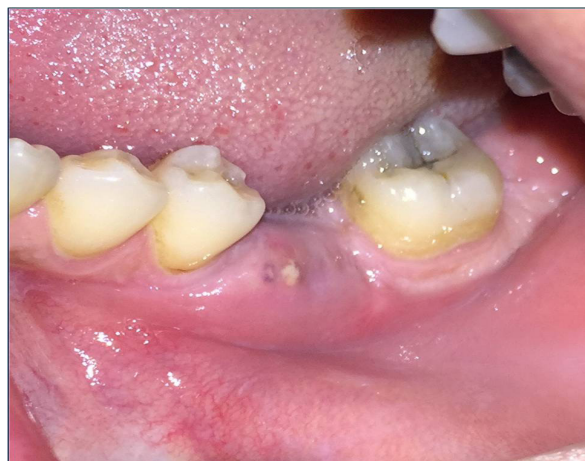
Figure 1. Pre-operative intraoral view of the implant side

weeks after surgery, the patient was returned with symptoms characterized by swelling, pain and inflammation on crestal mucosa of implant side (Figure 1). The closure screw loosening was occurred on the panoramic radiograph (Figure 2).

A crestal incision was made over the implant side, mobilized screw was removed and intraoral drainage was performed. After this procedure, a healing cap was placed and

incision was sutured. Medication therapy (Amoxicillin Clavulanate 1000 mg, Ibuprofen, Chlorhexidine gluconate) was started to resolution of the infection for seven days. The patient was completely asymptomatic during the healing period. Eight weeks later a panoramic radiography revealed a non-inflamed mucosa with no pathology evident. After the healing and osseointegration period of 2 months, implant retained single crown was finished (Figure 3-4). Follow-up period obtained five months later showed favorable results.
